# VEHICLE INSPECTION REPORT

**PJ20EDK**

## Fiat Ducato 35 2.3 Multijet 140PS

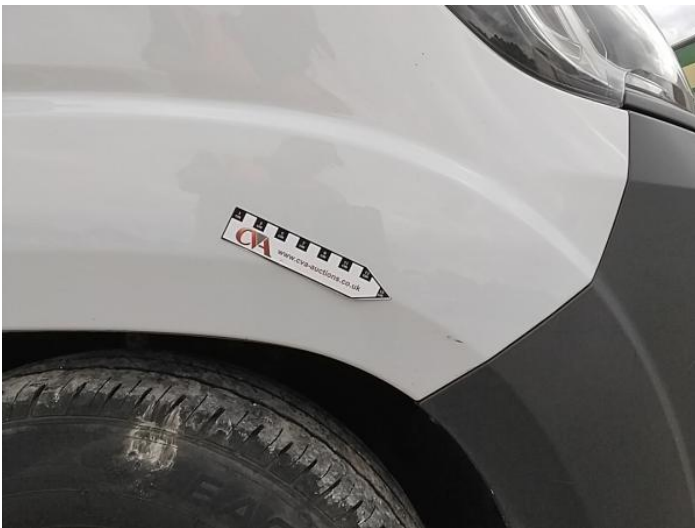
1: Wing of  
Scratched  
Up To 25mm Thru Paint

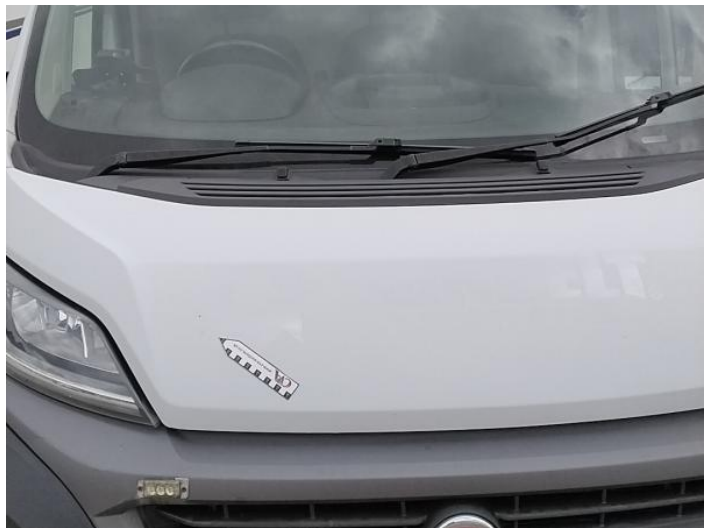
2: Bonnet  
Chipped  
Multiple Chips

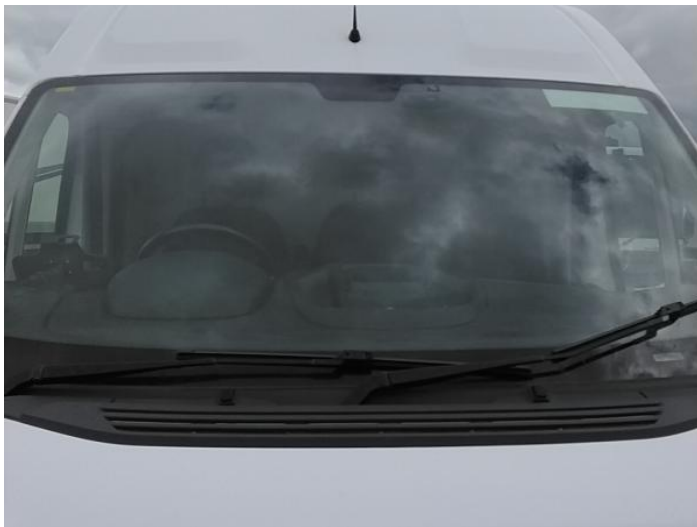
3: Screen Front  
Chipped  
Over 10mm

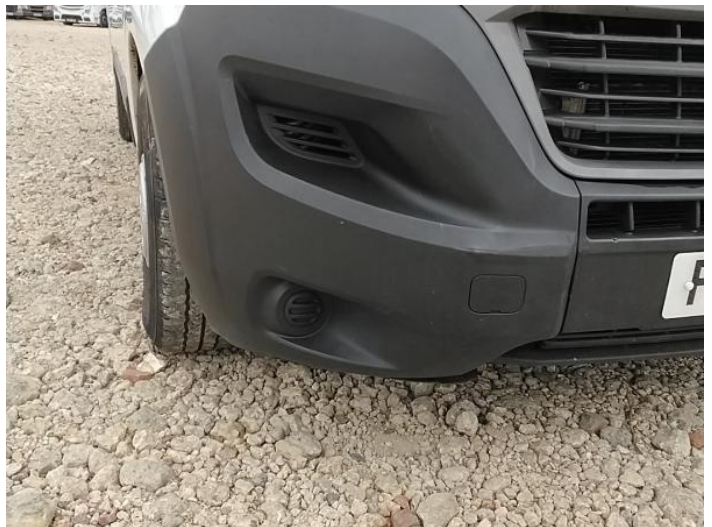
4: Bumper Front  
Dented  
2 Or Less UpTo 10mm

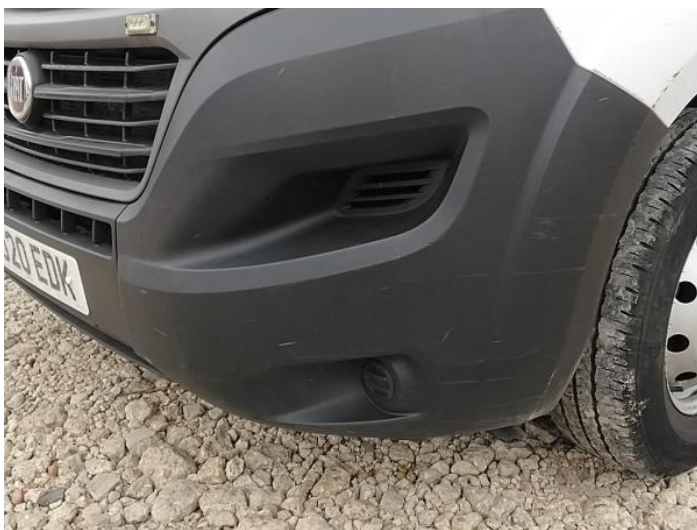
5: Bumper Front Moulding  
Scuffed (Unpainted)  
Over 100mm

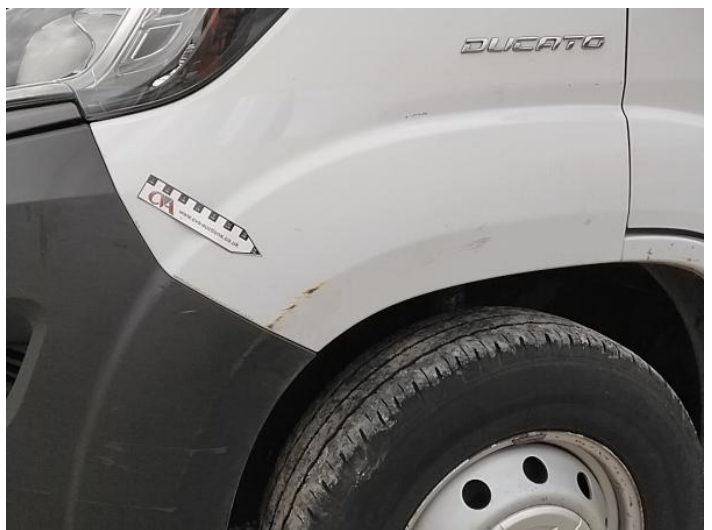
6: Wing nsf  
Scratched  
Over 25mm Thru Paint

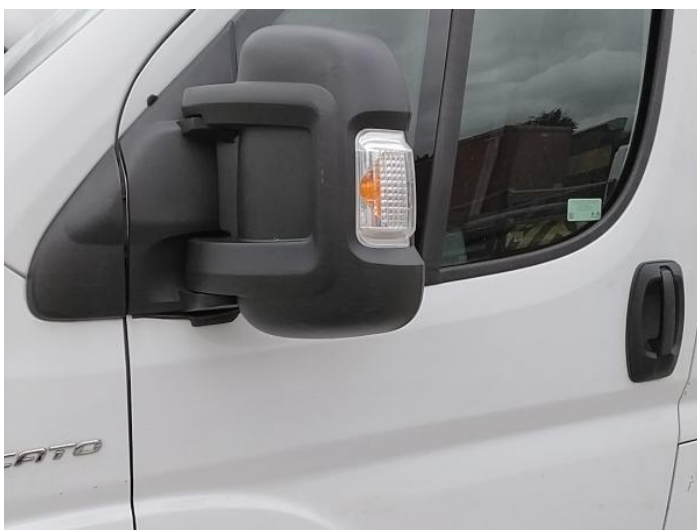
7: Door Mirror Assy nsf  
Scuffed (Unpainted)  
UpTo 100mm

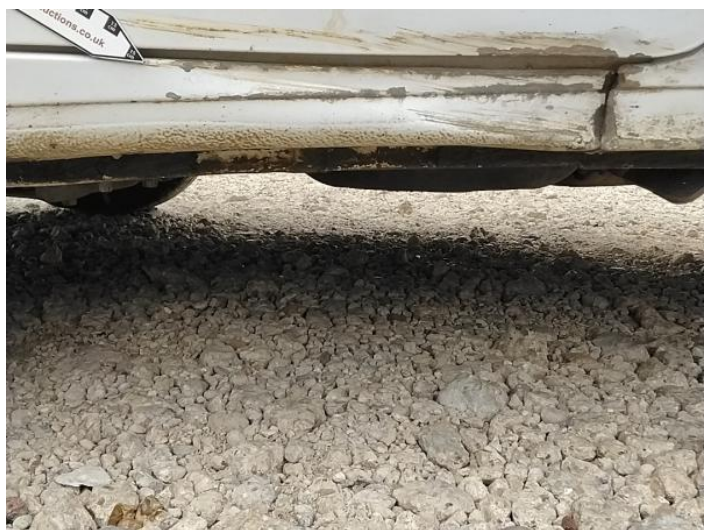
8: Sill ns  
Dented  
With Paint Damage

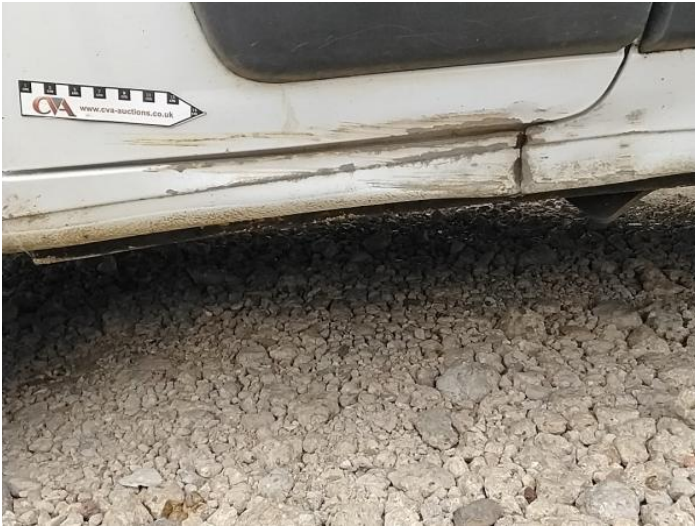
9: Door nsf  
Dented  
With Paint Damage

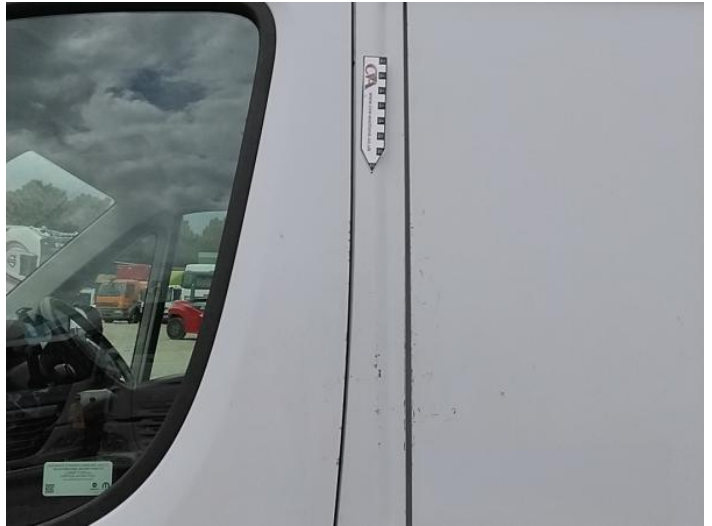
10: B Post ns  
Chipped  
Multiple Chips

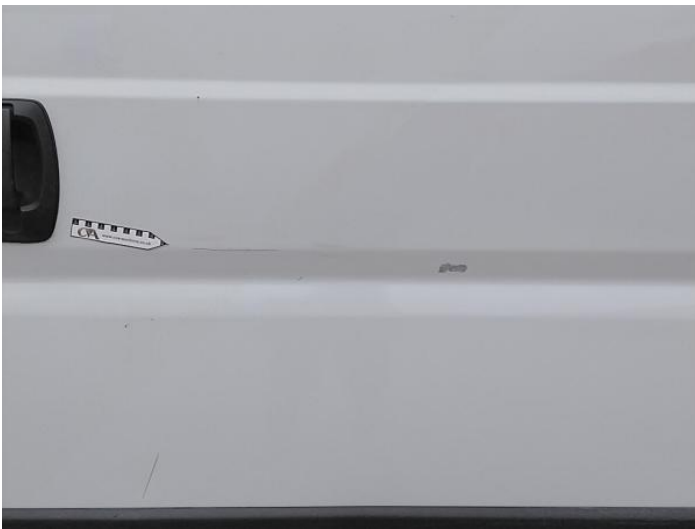
11: Door nsr  
Scratched  
Over 25mm Thru Paint

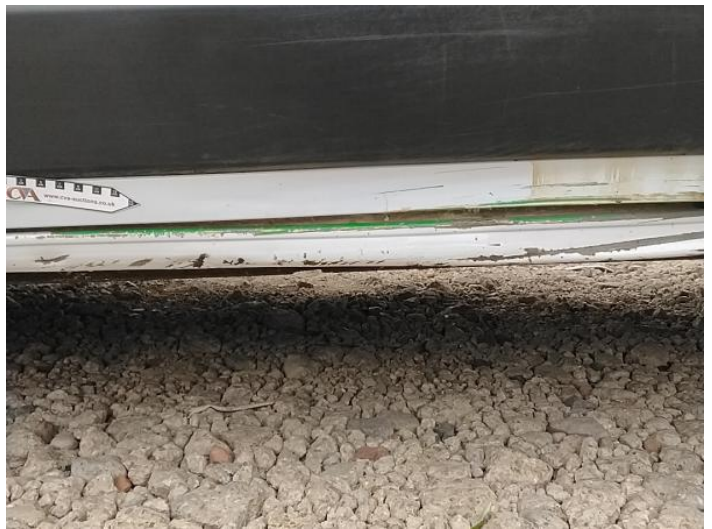
12: Door nsr  
Dented  
With Paint Damage

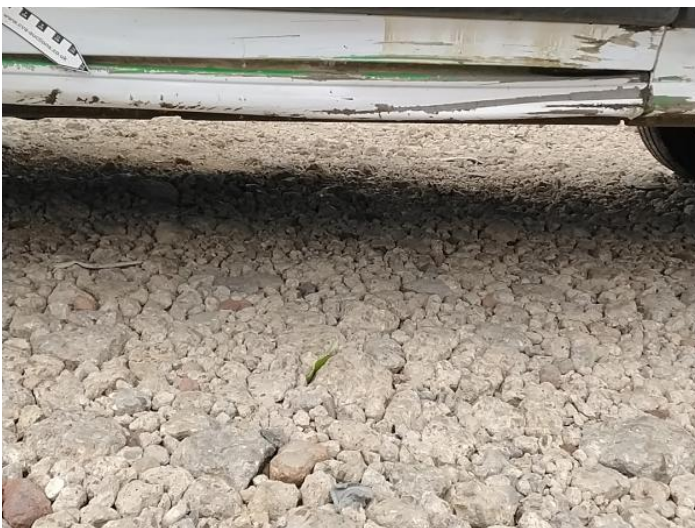
13: Sill ns  
Dented  
With Paint Damage

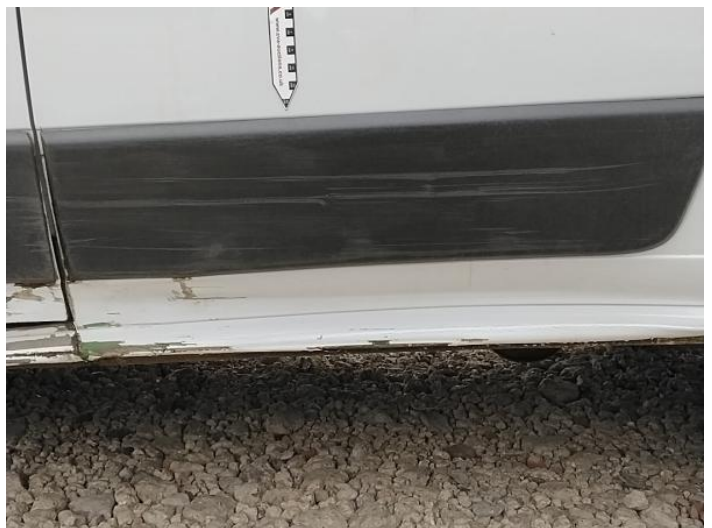
14: Qtr Panel Moulding ns  
Scuffed (Unpainted)  
Over 100mm

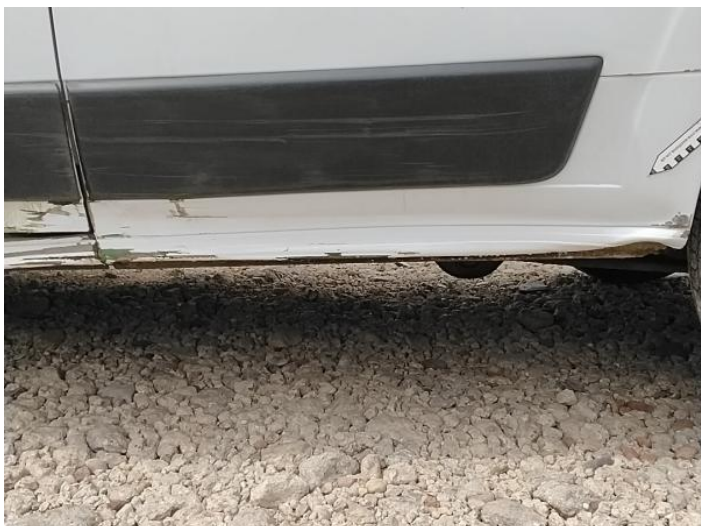
15: Sill ns  
Dented  
With Paint Damage

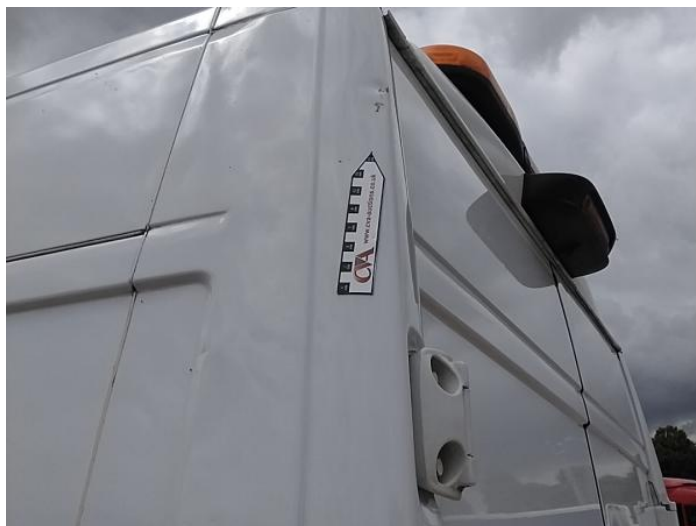
16: Qtr Panel nsr  
Dented  
With Paint Damage

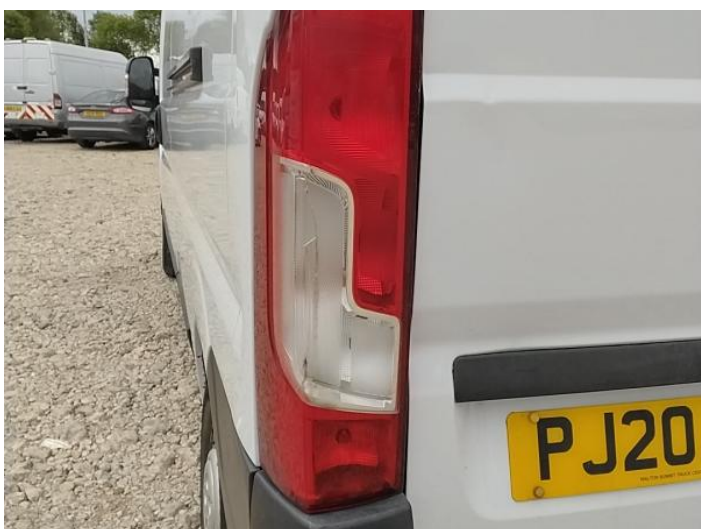
17: Lamp nsr  
Broken  
Replace

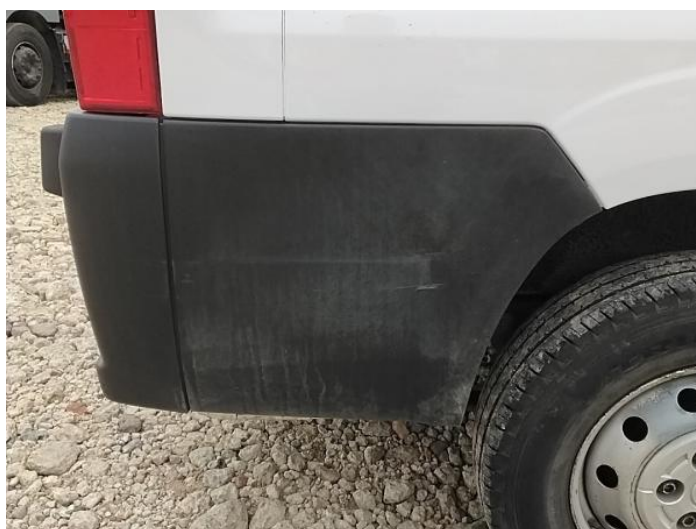
18: Qtr Panel Trim os  
Scuffed  
Over 25mm

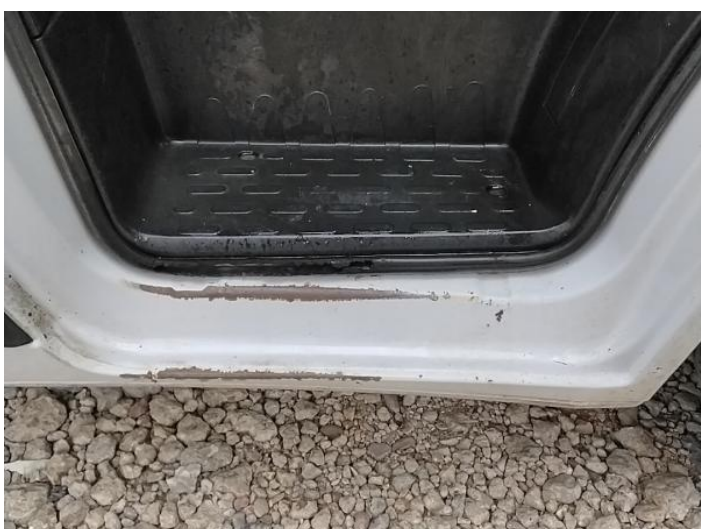
19: Sill os  
Rusted  
Over 5mm

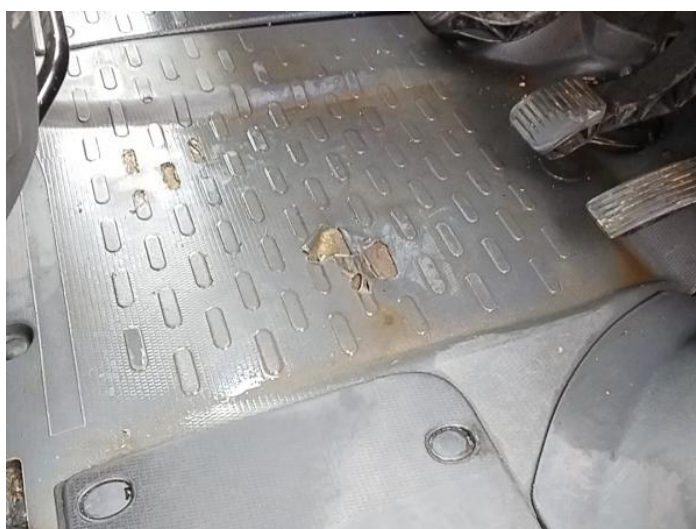
20: Seat Base Cover osf  
Holed  
Over 3mm
