# VEHICLE INSPECTION REPORT

**SJ65GKG**

## MERCEDES-BENZ ANTOS 1827

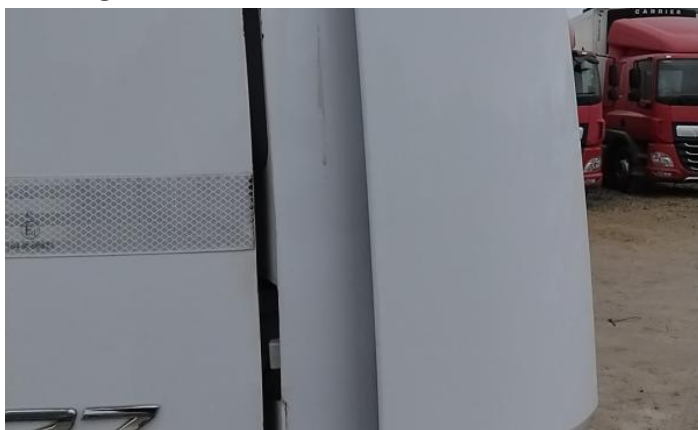
1: Wing osf  
Scratched  
Over 25mm Not Thru Paint

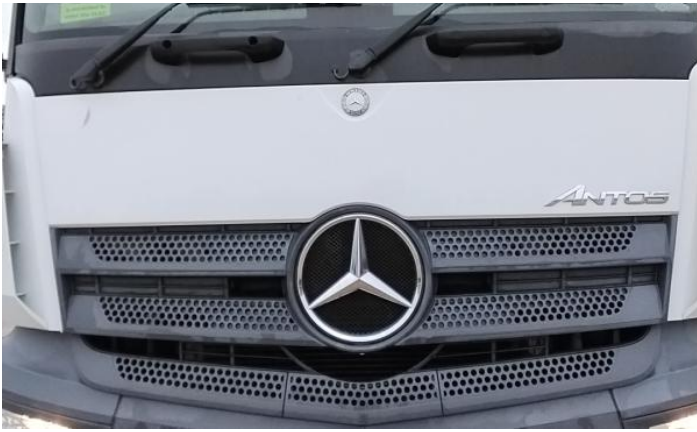
3: Bonnet  
Chipped  
1 To 5

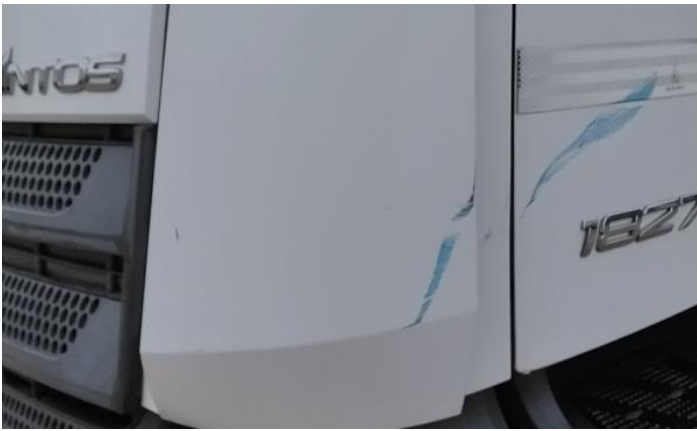
5: Wing nsf  
Scratched  
Over 25mm Not Thru Paint

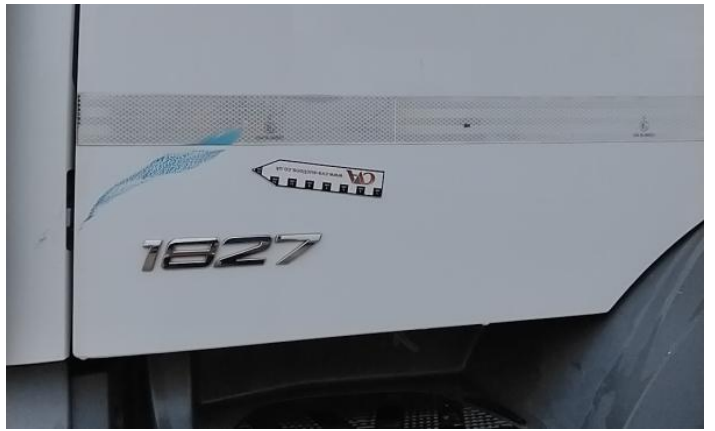
6: Door nsf  
Scratched  
Over 25mm Not Thru Paint

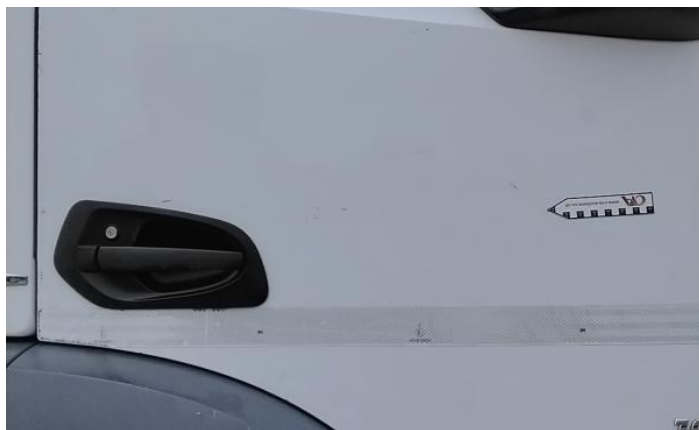
14: Door osf  
Scratched  
Over 25mm Thru Paint

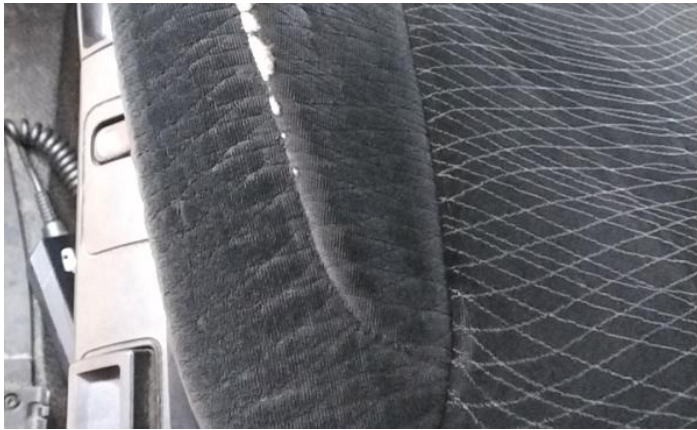
15: Seat Base Cover osf  
Holed  
Over 3mm

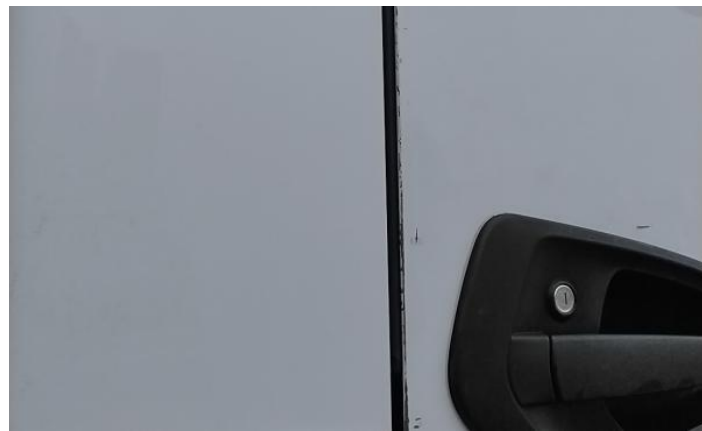
17: Door osf  
Chipped  
Edge Chip
